DOT/FAA/AR-96/48

Fuel Fire Penetration Test and Destruction of a Transport Aircraft

December 1996

Final Report

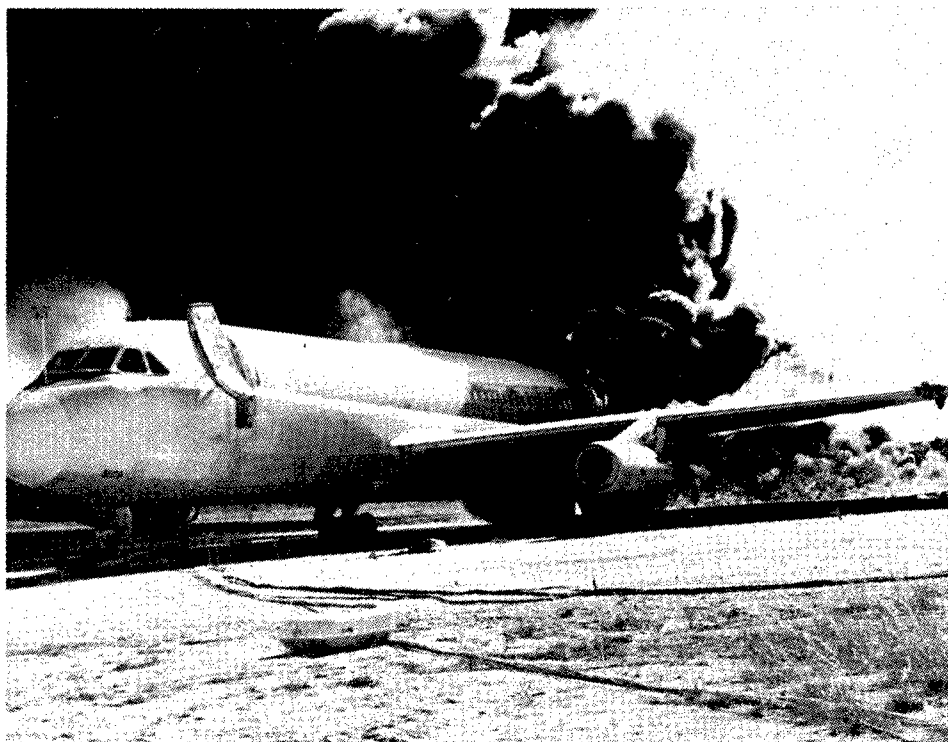
FLAME IMPINGEMENT. The pool fire became fully developed 20 seconds after ignition. The wind driven flame (60° left of the nose at an average speed of 12 knots) struck the fuselage between stations 1070 and 1300 trailing towards the rear of the aircraft and covering the top of the fuselage from station 1200 aft (figures 2, 3). A small amount of flame blew under the fuselage aft of the right rear door from station 1294 aft. A relatively large amount of flame blew over the fuselage from station 1220 aft to the vertical stabilizer. Occasionally, the flame from under the fuselage and the flame from over the fuselage combined in the vicinity of the right rear door, station 1262. The fire remained fairly constant for approximately 8 minutes then diminished as the fuel was exhausted until it was out at 11 minutes.

FIGURE 2. FLAME IMPINGEMENT ON PORT AFT FUSELAGE

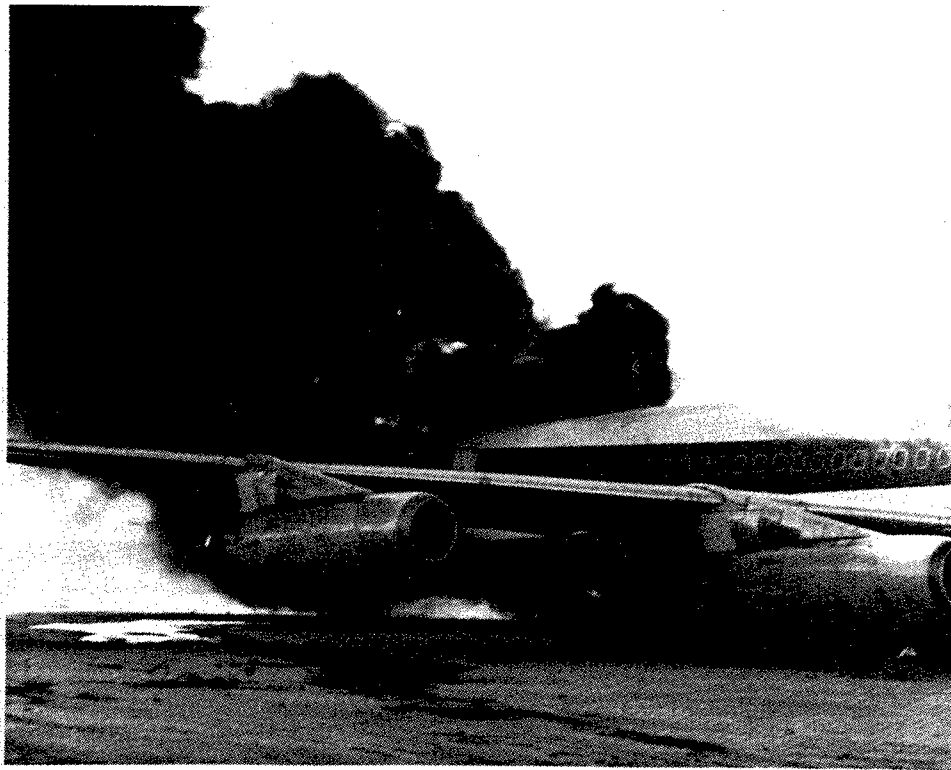
FIGURE 3. FLAME IMPINGEMENT ON STARBOARD AFT FUSELAGE

The thermocouples installed on the starboard side at both the cheek area and the window level were not directly impinged by the fuel fire plume. The external air temperature at both locations remained quite low until the tail separated from the aircraft at the 8-minute mark. This exposed the thermocouples to the diminishing pool fire (figures B-4 and B-5).

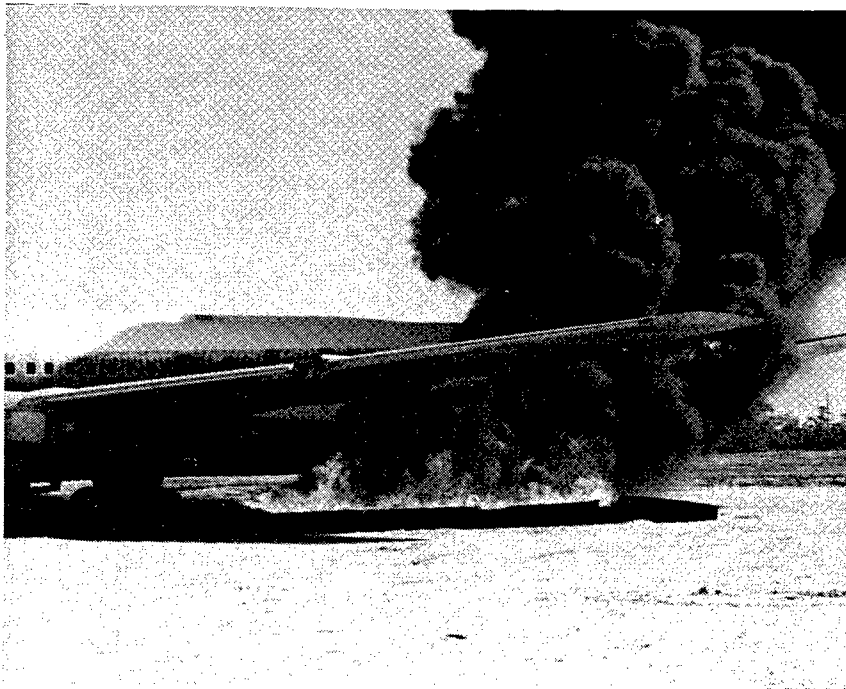
The external fuel fire burned steadily for 8 minutes and did not self-extinguish from lack of fuel until 11 minutes 15 seconds had elapsed. The fire plume was blown by the 12-knot wind against and over the rear fuselage (figures 4 and 5). However, long before the pool fire was out, the interior of the aircraft supported a self-sustaining cabin fire. Two minutes twenty-five seconds after the pool ignition a visible seat fire was observed in the main cabin. Two minutes thirty seconds into the test, heavy black smoke was observed pouring from the starboard rear service door. A small fireball erupted from the starboard rear service door at 2 minutes 47 seconds.

FIGURE 5. FULLY DEVELOPED FUEL FIRE, 20 SECONDS AFTER IGNITION

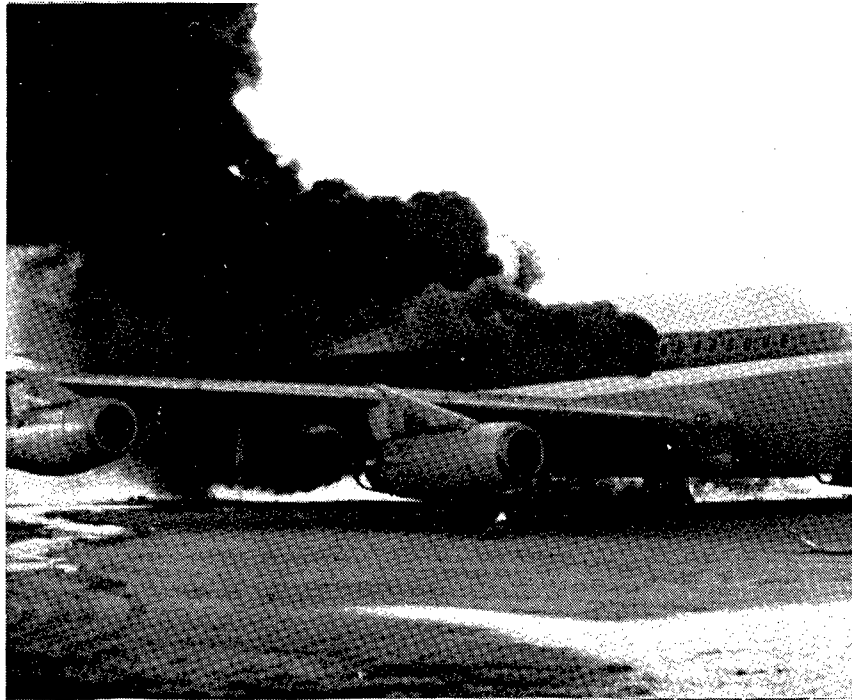
A flash fire occurred in the empennage crawlthrough at 2 minutes 51 seconds. Intermittent fire was observed coming out of the right rear service door beginning at 3 minutes 30 seconds. Heavy black smoke began to pour from the right overwing emergency door at 3 minutes 35 seconds (figure 6). White smoke began to pour from the right forward service door at 3 minutes 58 seconds. This quickly changed to heavy black smoke at 4 minutes 20 seconds.

FIGURE 6. SMOKE POURS FROM STARBOARD OVERWING EXIT, 3 MINUTES 35 SECONDS AFTER IGNITION

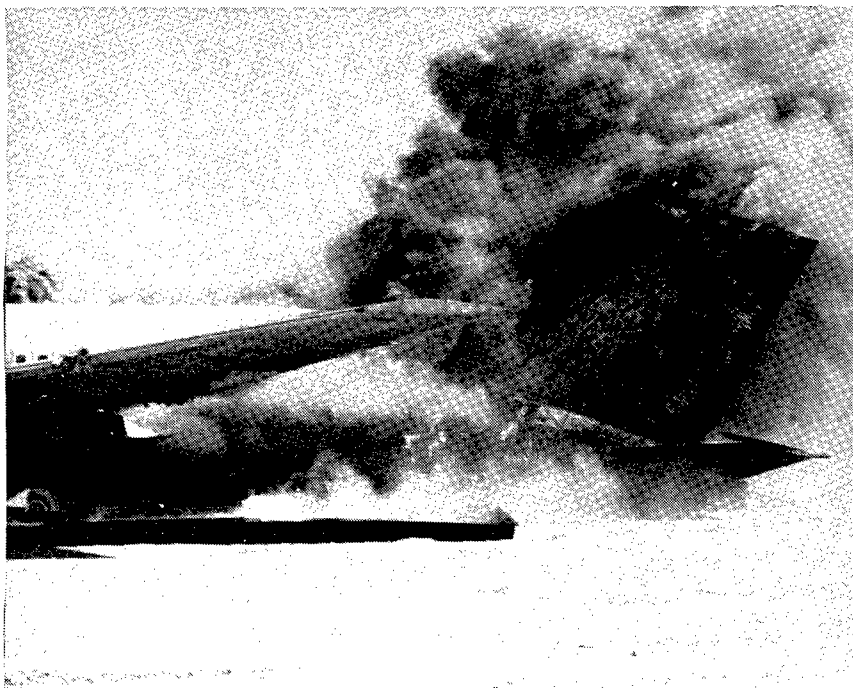
The entire tail section of the aircraft separated at approximately station 1264 and collapsed to the ground at 8 minutes 12 seconds (figure 7).

FIGURE 7. TAIL SEPARATES FROM FUSELAGE, 8 MINUTES 12 SECONDS AFTER IGNITION

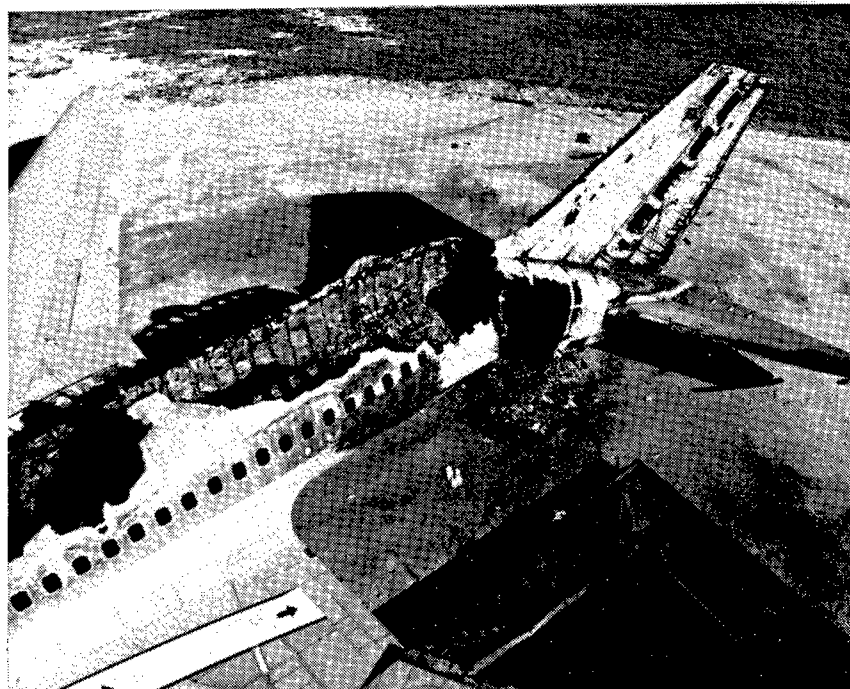
The entire interior of the aircraft was completely gutted. There were no recognizable interior furnishings. All of the windows, with the exception of those on the flight deck, were consumed. The top of the fuselage was burned down to just above the windows (figures 12 and 13). The entire empennage assembly was separated from the fuselage at station 1264 (figure 14). The cabin floor was consumed aft of the main wing spar. Forward of the main wing spar, the floor was intact as well as the forward cargo compartment. The remaining floor support beams were weakened, twisted, and sagging.

FIGURE 13. AERIAL VIEW OF CABIN AFT AFTER FIRE

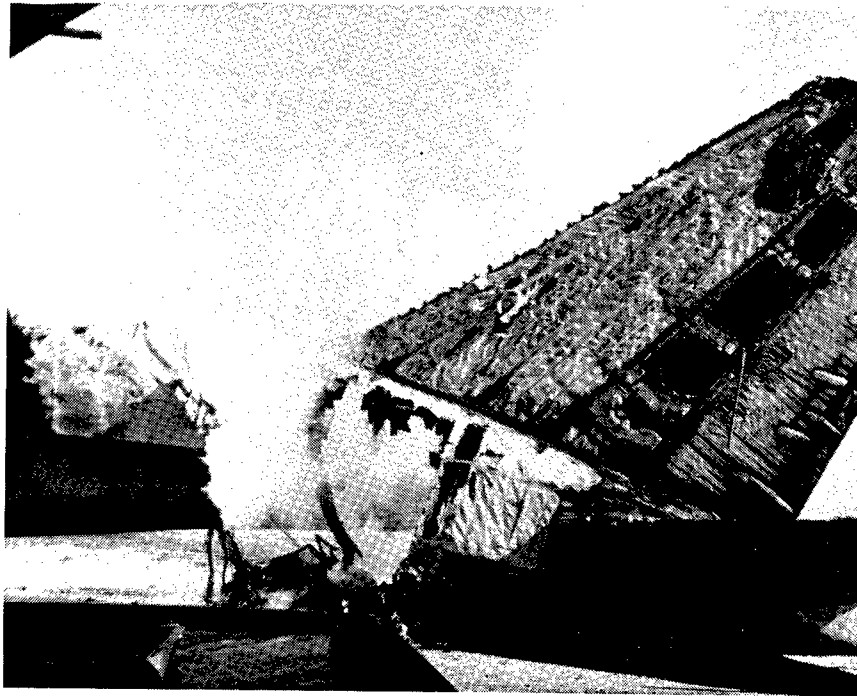
FIGURE 14. THE EMPENNAGE SEPARATED FROM THE FUSELAGE AT STATION 1264

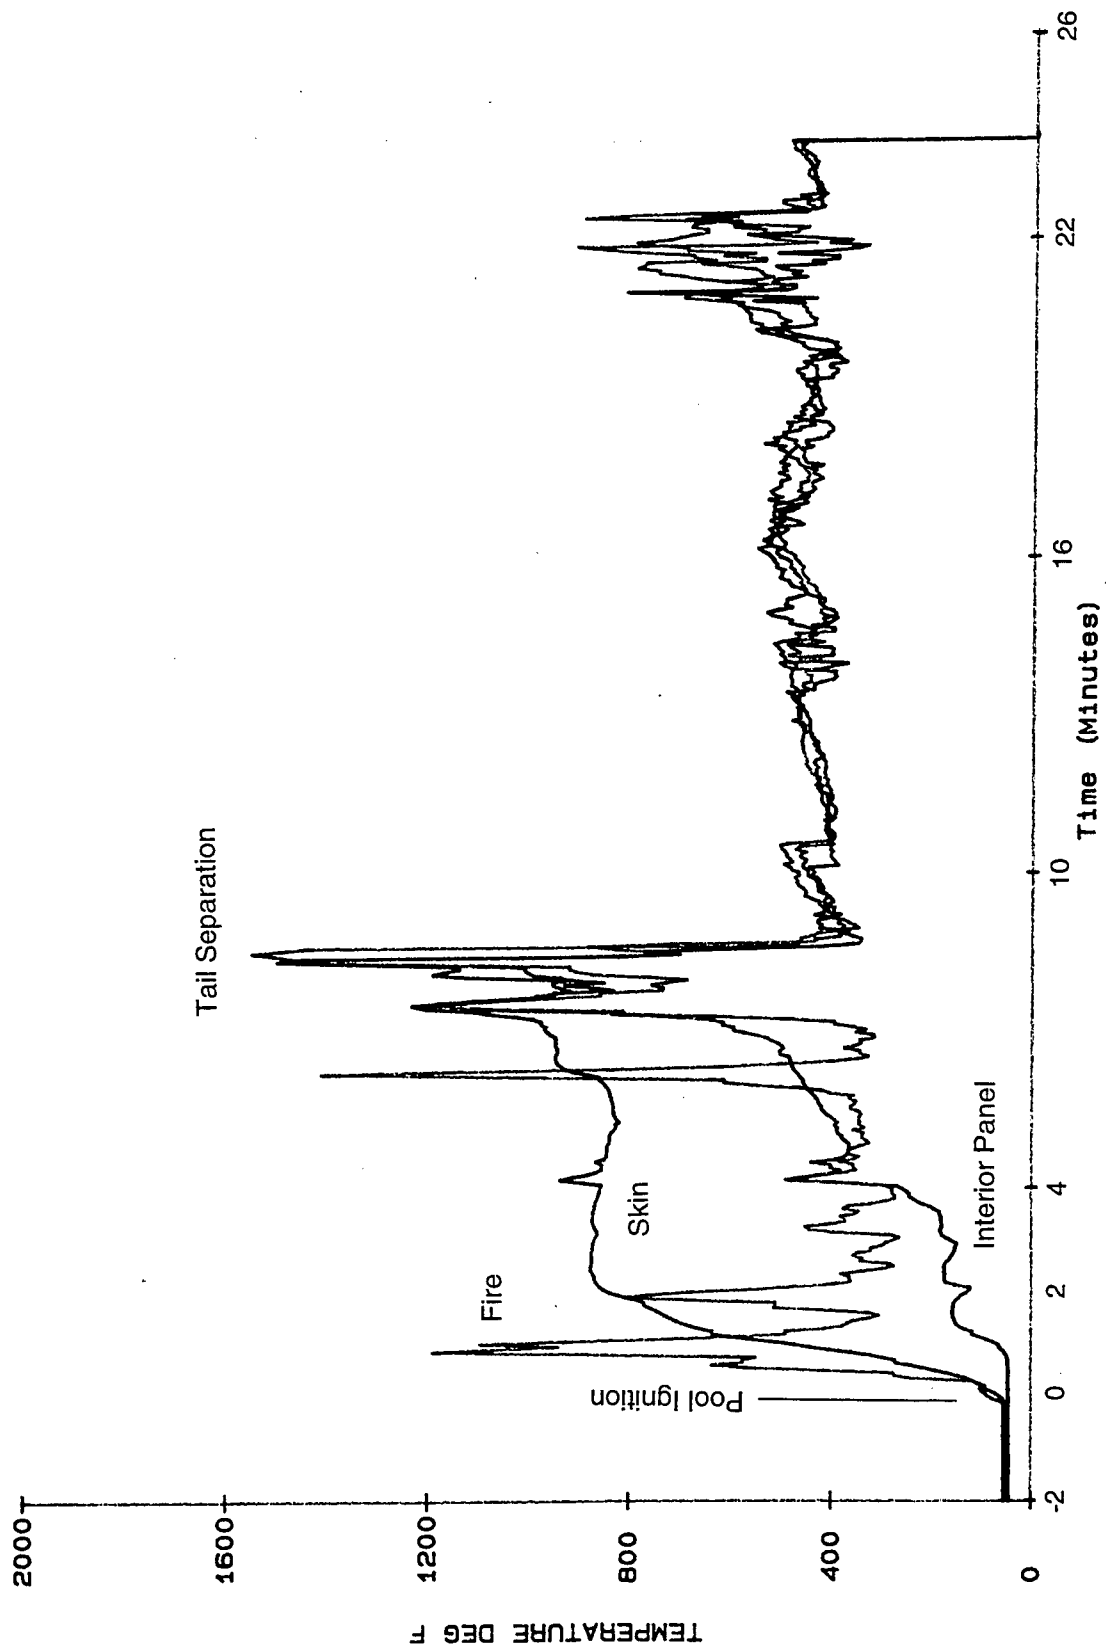
Thermocouple temperatures recorded outside the fuselage at station 1192 measured just below the base of the window peaked at 1200°F 1 minute after pool ignition then subsided to an average of 400°F until the 8-minute mark when the temperature again peaked at 1400 and 1600°F at the 9-minute mark (figure B-1). The heat flux at this location peaked at 19 BTU/ft²-sec but averaged 5 BTU/ft²-sec (figure B-2). These measurements were 2 to 3 feet forward of the flame plume. The flame temperature at the cheek area, also at station 1192, followed the same trend as figure B-1 (figure B-3).

Figure B-1 shows the temperature profile on the port side just below the window. The skin temperature reached 900°F, which is the approximate incipient melt point for aluminum, in 2 minutes. The cabin sidewall, however, stayed relatively cool reaching only 150°F in this period. It should be noted that this skin location was only in the fuel fire for a very short period of time.

FIGURE B-1. TEMPERATURE PROFILE THROUGH FUSELAGE SKIN AT STATION 1192, BELOW THE WINDOW, PORT SIDE

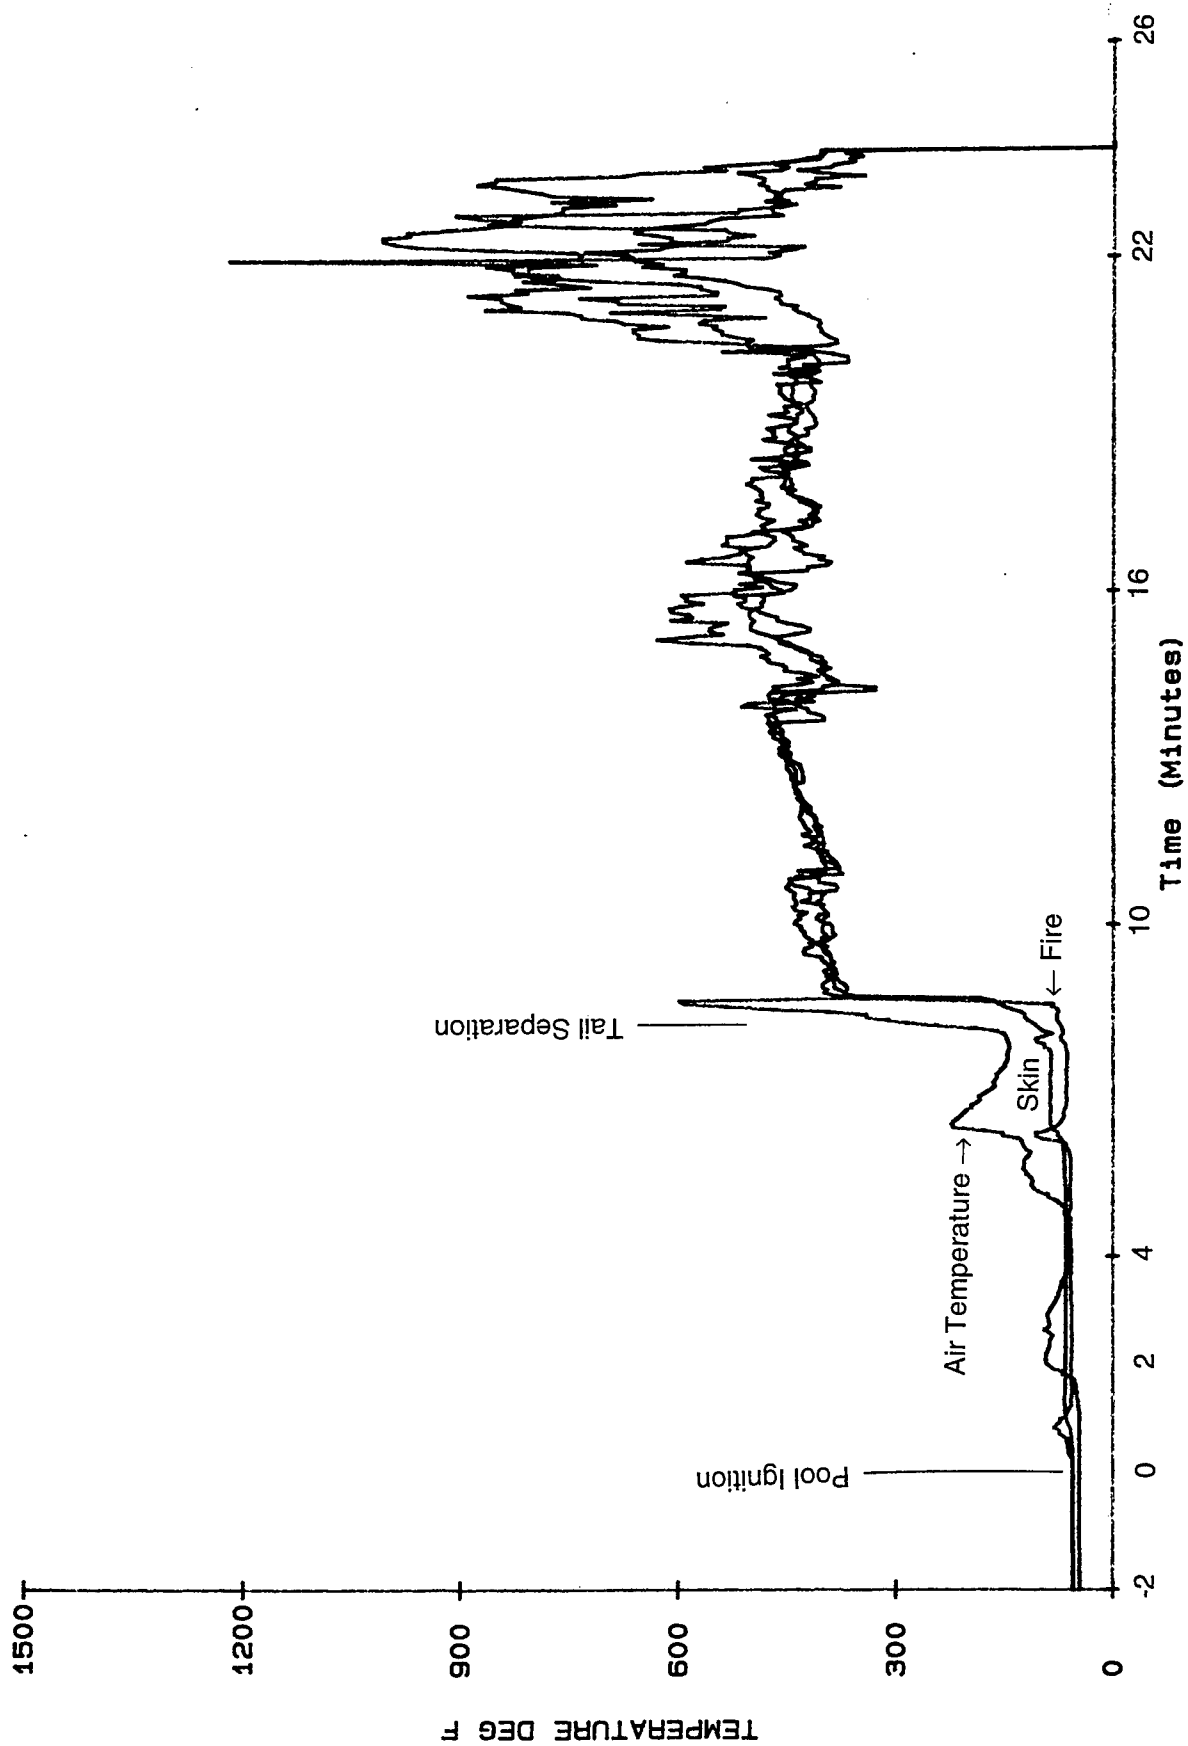
FIGURE B-4. TEMPERATURE PROFILE THROUGH FUSELAGE SKIN AT STATION 1192, CHEEK AREA, STARBOARD SIDE
